The Effectiveness of Centrifugal Pump Shaft Alignment Process Against Vibration Reduction

In the oil and gas industry, pumps play a very important role where pumps are used to drain liquids such as condensate and water. Various types of pumps are used for various purposes according to their functions, one of which is the 11-PA-7131A pump which is used in producing water in PT. Pertamina Hulu Mahakam

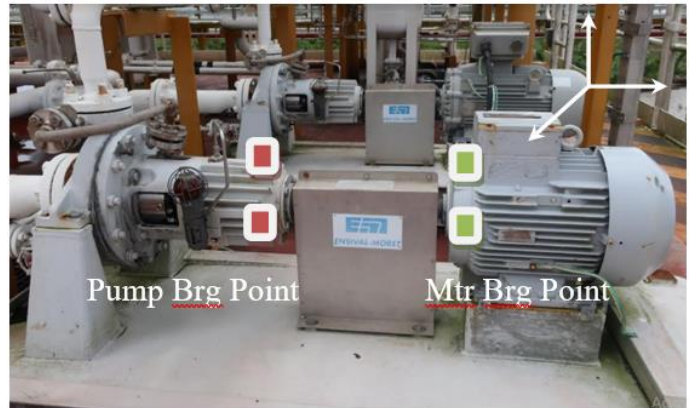
Figure 1. Vibration point

According to the review that has been carried out and the vibration data that has been taken, we will enter the data into the software which will later get vibration spectrum data. From these data we will analyze what problems occur with the pump and motor. Vibration data collection is carried out in two parts, namely the motor side and the pump side. Vibration data collection point as shown in the following figure

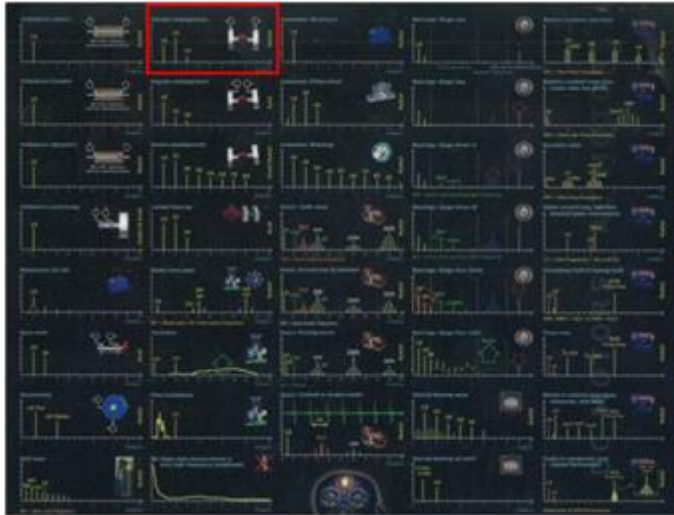
Figure 3. Vibration analysis chart

Based on the vibration analysis chart listed below, we will analyze the vibration spectrum that has been taken on the pump unit 11-PA-7131A. The analysis will be carried out by looking at the vibration spectrum that has been taken on the motor and also the vibration spectrum on the pump.

In the motor vibration spectrum it can be seen that the dominant amplitude is at a frequency of 5760 cpm (2X) of 5.28 mm/s and followed by a frequency of 2880 cpm (1X) of 4.55 mm/s. Based on the spectrum signal data above, it shows that the shaft on the motor experiences parallel misalignment due to a high amplitude at order 2X which is also followed by a high amplitude at order 1X.

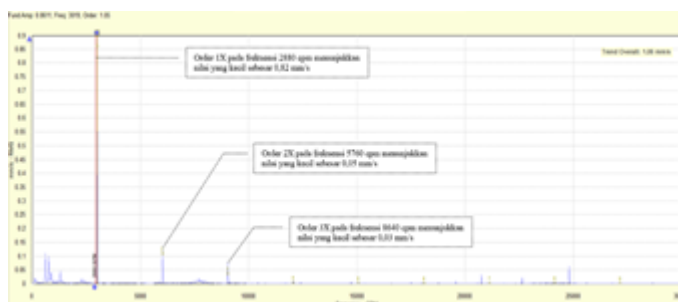
Figure 5. Motor vibration spectrum (alignment)

In the motor vibration spectrum signals in shaft alignment conditions, the amplitude values for each order are not high and only within normal limits. If we look at the amplitude at a frequency of 2880 cpm (1X) it is 0.82 mm/s and the amplitude at 5760 cpm (2X) is 0.05 mm/s. The amplitude of vibration at a frequency of 8640 cpm (3X) is 0.03 mm/s.

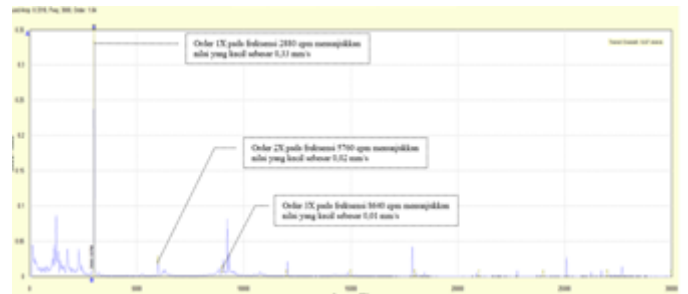
Figure 7. Pump vibration spectrum (alignment)

In the vibration spectrum signal on the pump which is in shaft alignment condition, the amplitude value in each order is also not high and only within normal limits. If we look at the amplitude at a frequency of 2880 cpm (1X) it is only 0.33 mm/s and the amplitude at 5760 cpm (2X) is 0.02 mm/s. The amplitude of vibration at a frequency of 8640 cpm (3X) is 0.01 mm/s.

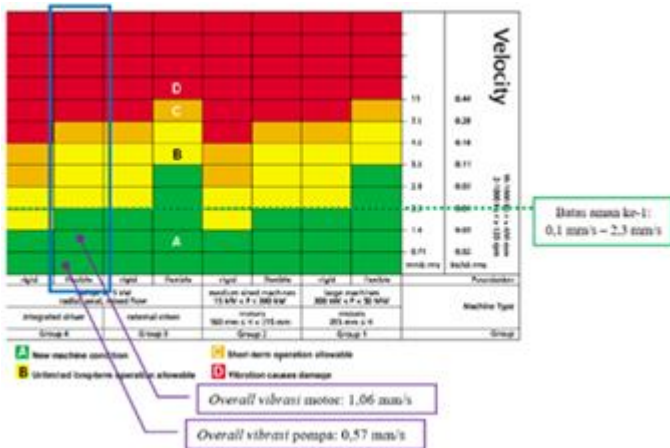
Figure 9. Overall vibration (alignment)

After shaft alignment, the overall vibration on the motor is 1.06 mm/s and the overall vibration on the pump is 0.57 mm/s included in the 1st safe limit category, which means the pump can be operated continuously safely.

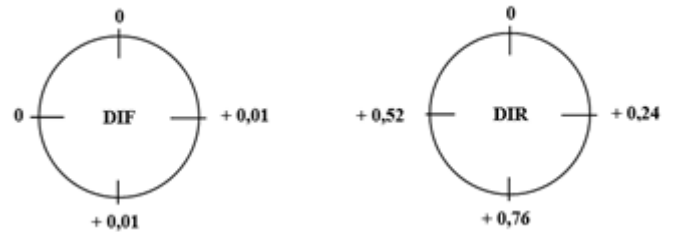
Figure 11. Dial indicator reading

1. The circumference diameter of the dial indicator = 50 mm.
2. The distance from the dial indicator rim to the foot of the front of the motor = 120 mm.
3. The distance from the front foot to the rear foot of the motor = 140 mm

- Rim Dial Vertical (DIR)
 - Tir = Total indicator reading rim = 0,76 - 0 = 0,76 mm
 - Face Dial Vertical (DIF)
 - Tir = Total indicator reading face = 0,01 - 0 = 0,01 mm
- Rim Dial Horizontal (DIR)
 - Tir = Total indicator reading rim = 0,24 - 0,52 = -0,28 mm
- Face Dial Horizontal (DIF)
 - Tir = Total indicator reading face = 0,01 - 0 = 0,01 mm

$$\begin{aligned} \text{Coupling offset} &= \frac{(\text{DIR}) \text{ Tir Vertical}}{2} \\ &= 0,76/2 \\ &= 0,38 \text{ mm} \\ \text{Shaft tilt} &= \frac{(\text{DIF}) \text{ Tir Vertical}}{\text{A Dimension}} \\ &= 0,01/50 \\ &= 0,002 \text{ mm} \end{aligned}$$

$$\begin{aligned} \text{Front feet} &= \frac{[(\text{DIF Tir}) B] + 1/2 \text{ DIR Tir}}{A} \\ &= \frac{[(0,01) 120] + 1/2 (0,76)}{50} \\ &= (0,024) + (0,38) \\ &= 0,404 \text{ mm} \end{aligned}$$

With this result, the shim on the front leg of the motorbike must be reduced by 0.404 mm.

$$\begin{aligned} \text{Rear feet} &= \frac{[(\text{DIF Tir}) B + C] + 1/2 \text{ DIR Tir}}{A} \\ &= \frac{[(0,01) (120 + 140)] + 1/2 (0,76)}{50} \\ &= (2,6 / 50) + 0,38 \\ &= 0,052 + 0,38 = 0,432 \text{ mm} \end{aligned}$$

With this result, the shim on the rear leg of the motorbike must be reduced by 0.432 mm.

$$\begin{aligned} \text{Coupling offset} &= \frac{(DIR) Tir Horizontal}{2} \\ &= -0,28/2 \\ &= -0,14 \text{ mm} \\ \text{Shaft tilt} &= \frac{(DIF) Tir Horizontal}{A Dimension} \\ &= 0,01/50 \\ &= 0,002 \text{ mm} \end{aligned}$$

$$\begin{aligned} \text{Front feet} &= \frac{[(DIFTir) B] + 1/2 DIR Tir}{A} \\ &= \frac{[(0,01) 120] + 1/2 (-0,14)}{50} \\ &= (0,024) + (-0,07) \\ &= -0,046 \text{ mm} \end{aligned}$$

With this result, the front foot of the motor must be moved to the right by 0.046 mm.

$$\begin{aligned} \text{Rear feet} &= \frac{[(DIFTir) B + C] + 1/2 DIR Tir}{A} \\ &= \frac{[(0,01) (120 + 140)] + 1/2 (-0,28)}{50} \\ &= (2,6 / 50) - 0,14 \\ &= 0,052 - 0,14 \\ &= -0,088 \text{ mm} \end{aligned}$$

With this result, the rear leg of the motor must be moved to the right by 0.088 mm.

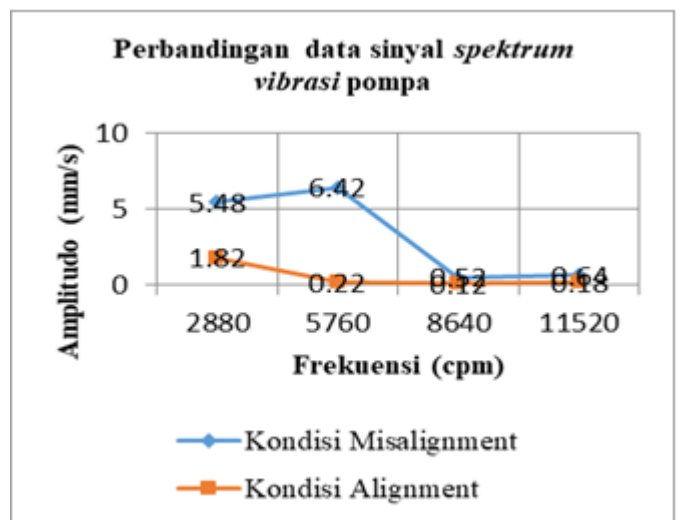
Figure 13 Pump vibration spectrum comparison graph

There was a decrease in the amplitude of the pump vibration spectrum signal after shaft alignment was carried

out at order 1X of 3.66 mm/s, at order 2X at 6.2 mm/s, at order 3X at 0.4 mm/s, and at order 4X at 0.46mm/s.
